7.1.4 Rain water harvesting

•Recharge of ground water: ZERO DISCHARGE CAMPUS APPROACH

CASE STUDY OF RAIN WATER HARVESTING IN LALAN CAMPUS BHUJ-KACHCHH

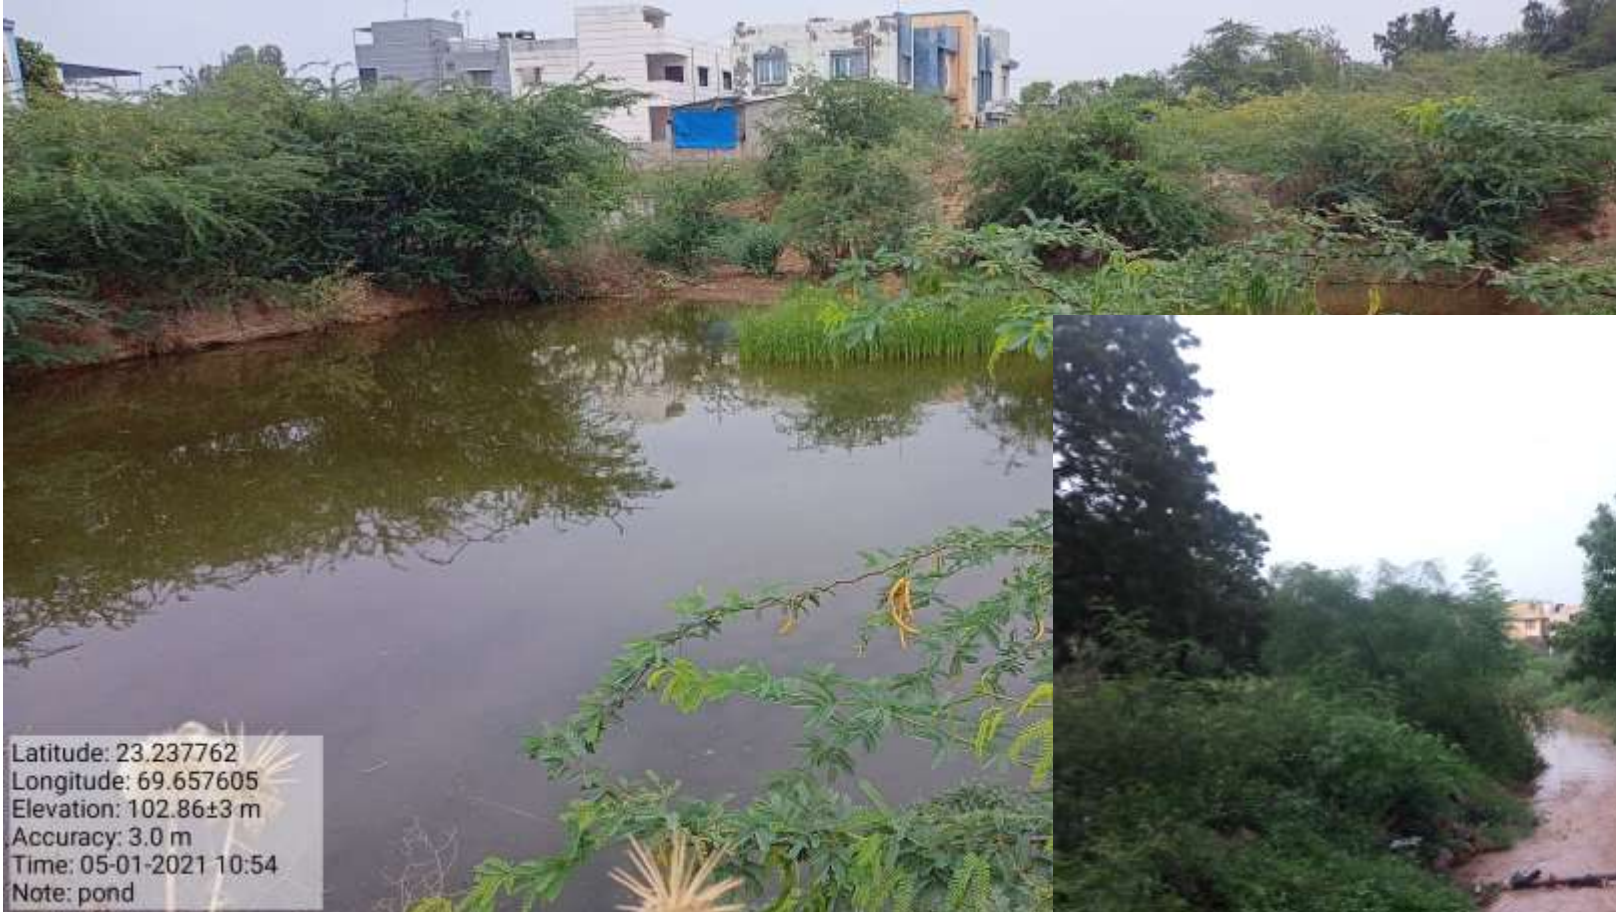
iv). College Pond (Percolation Tank): As part of water conservation and creating a natural ecosystem in the campus, college has developed a pond close to the water channel which is fully functional. College has a “Nala” (Runnel) passing through the campus. With an aim to develop a zero discharge campus we have developed a percolation tank past 3 years nearby the channel. The area of the percolation tank is ~ 1200 sq.m . (Please refer photograph)

Latitude: 23.237762
Longitude: 69.657605
Elevation: 102.86±3 m
Accuracy: 3.0 m
Time: 05-01-2021 10:54
Note: pond

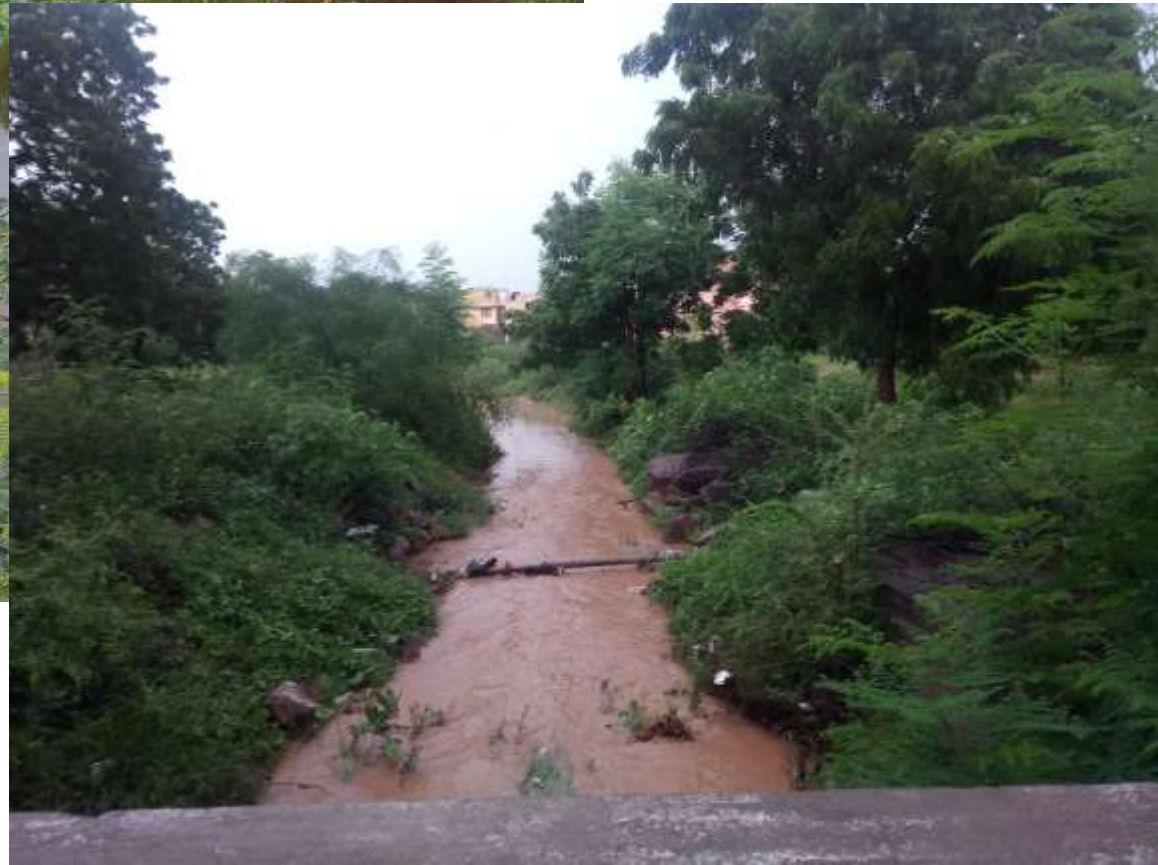
Recharge Pits (06 Pits in the campus)

ii). Ground water recharge: Recharge pits, ~ 6 recharge bores units are prepared in the college campus with different capacities. These were prepared in partnership with local NGO and college which can serve as a model for community.

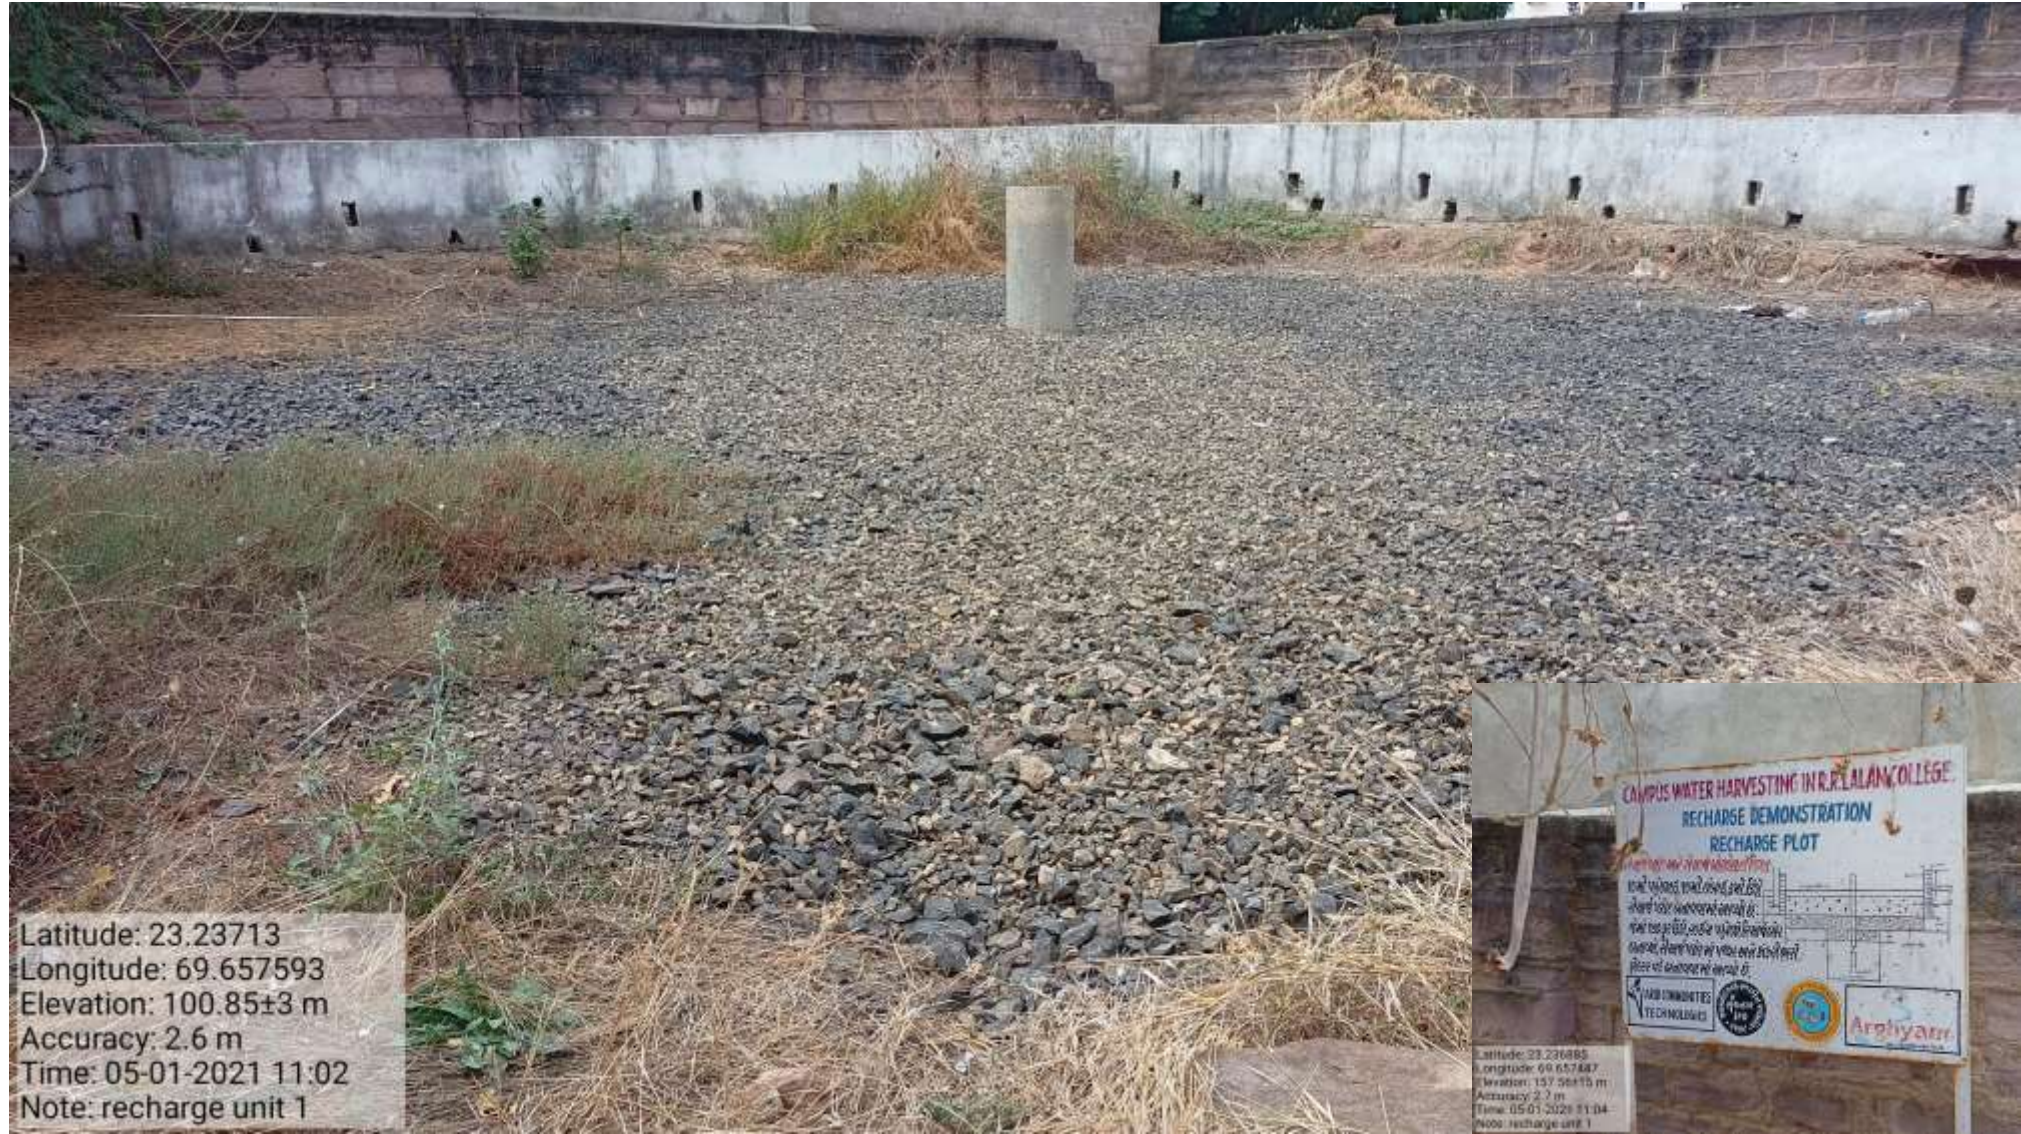
Recharge Bed

Latitude: 23.23713
Longitude: 69.657593
Elevation: 100.85±3 m
Accuracy: 2.6 m
Time: 05-01-2021 11:02
Note: recharge unit 1

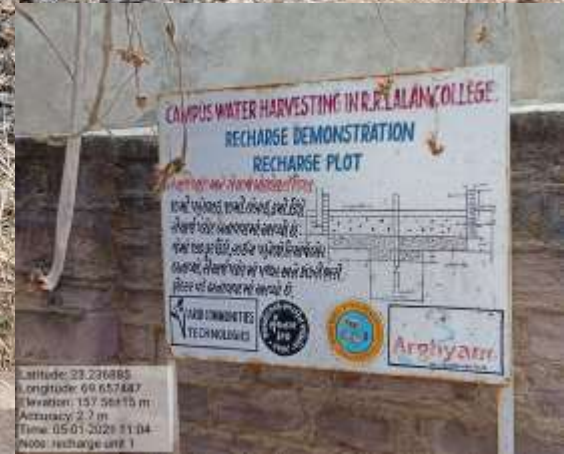
Latitude: 23.23685
Longitude: 69.657687
Elevation: 101.96±10 m
Accuracy: 2.7 m
Time: 05-01-2021 11:04
Note: recharge unit 1

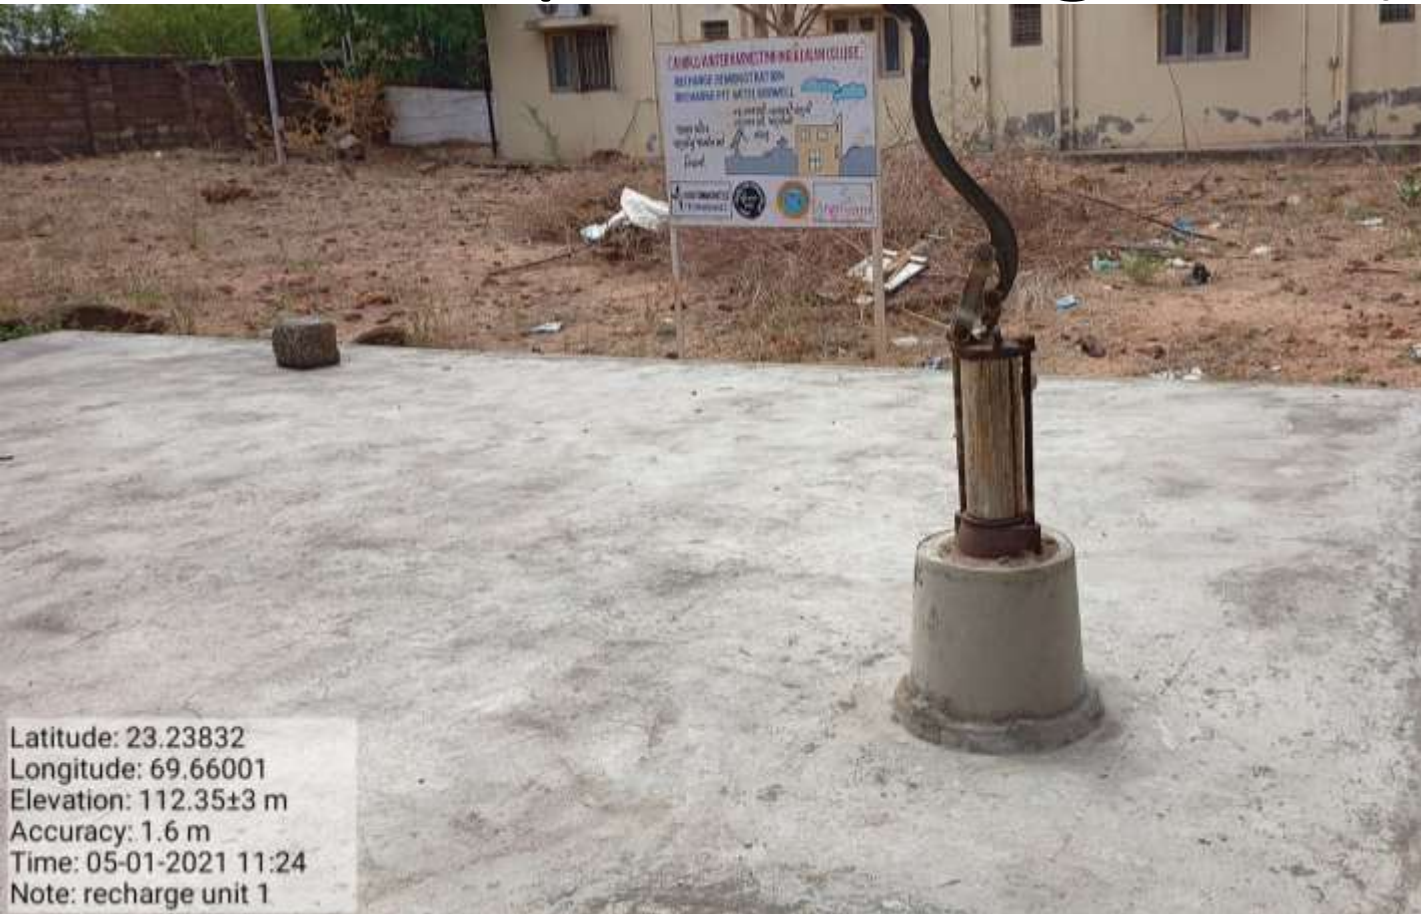
Roof top harvesting Tank (2 water tanks)

iii). Rain water storage: Roof top water from the 3 selected quarters are stored in the rain water storage tanks.

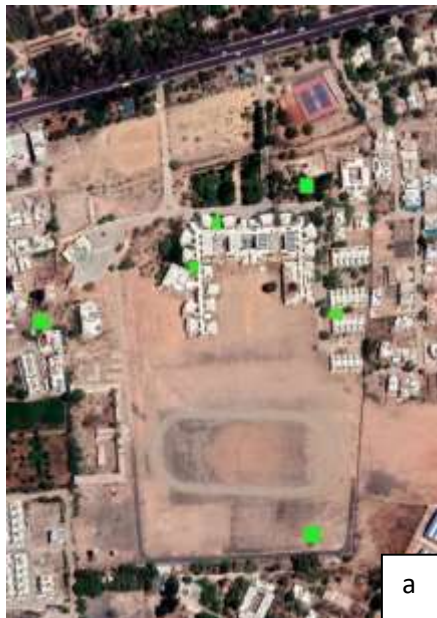
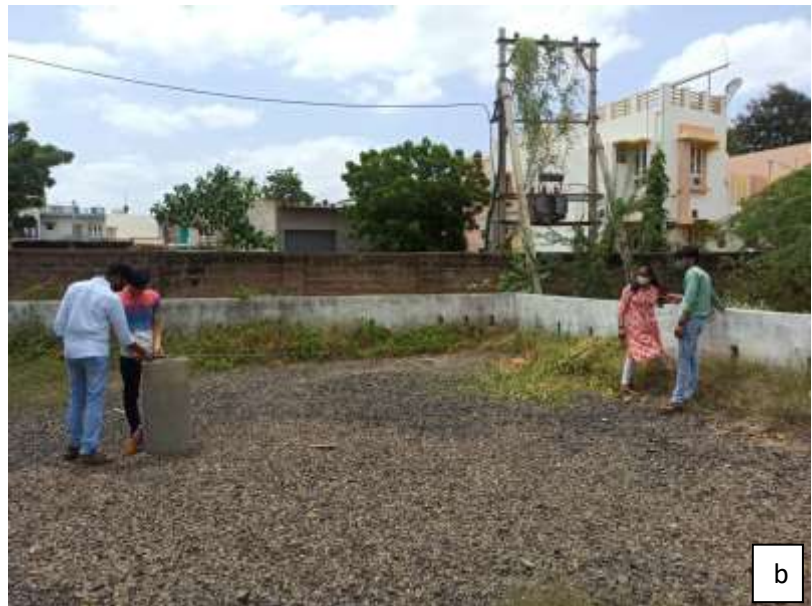
Figure 1a and 1b: Google earth image showing Lalan college, college building, and recharge well locations.

Recharge well near residential quarters 17is feet deep, the drinking water place one is 25 feet deep, and the one near library is 18 feet deep (figure -1). Later on, three more rechargewell/structures were placed. The dimensions of the recharge structurers were measured manually figure -1b. First is located near water storage tank which is 10 meter Wide 10 meter long and 3-meter-deep recharge pit with a 130 feet deep recharge well. The pit was later filled with gravel for better percolation. Second is located at south east of the sports ground of the campus which is 4 meter long 4 meter wide and 3-meter-deep pit with 30 feet deep recharge well. This pit too was later filled with gravel. Third is located in the botanical garden which is 3 meter long 3 meter wide and 3-meter-deep pit with a 9 feet deep recharge well. This pit also was later filled with gravel (figure -1).

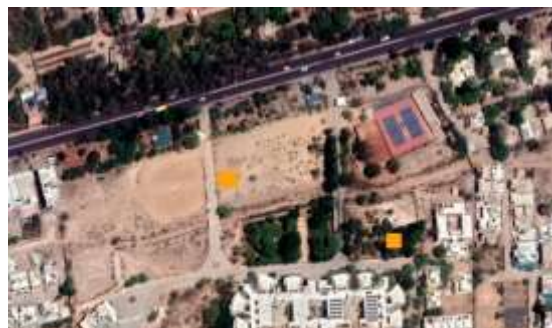
Figure 2: Google earth image showing the college campus, college building, and soil samples locations in orange square.

After the depth measurement of recharge wells the soil samples were collected (figure -2). About
 10 cm. of the soil was first scraped out to avoid organic matter and then about 20-30 grams of
 soil was collected. We took five soil samples from all over the campus which are as follows:

- A. Botanical garden
- B. South east of the sports ground
- C. South west of the sports ground
- D. Water storage tank
- E. Parking area

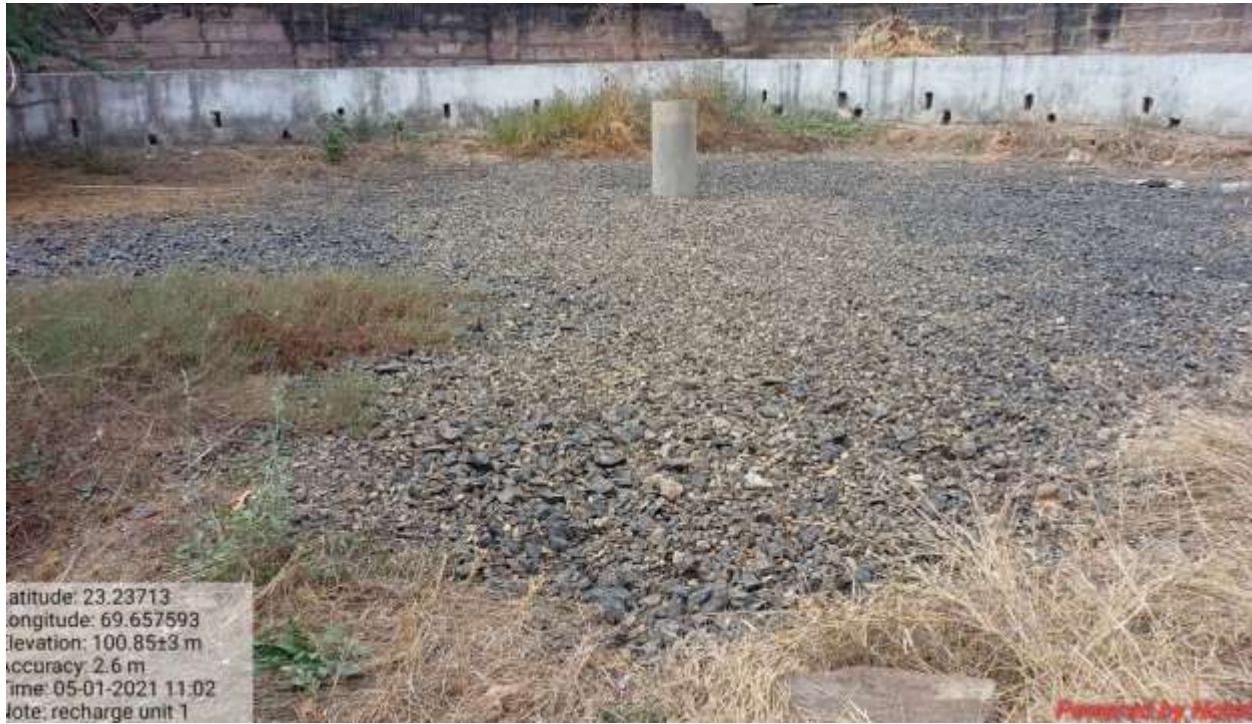
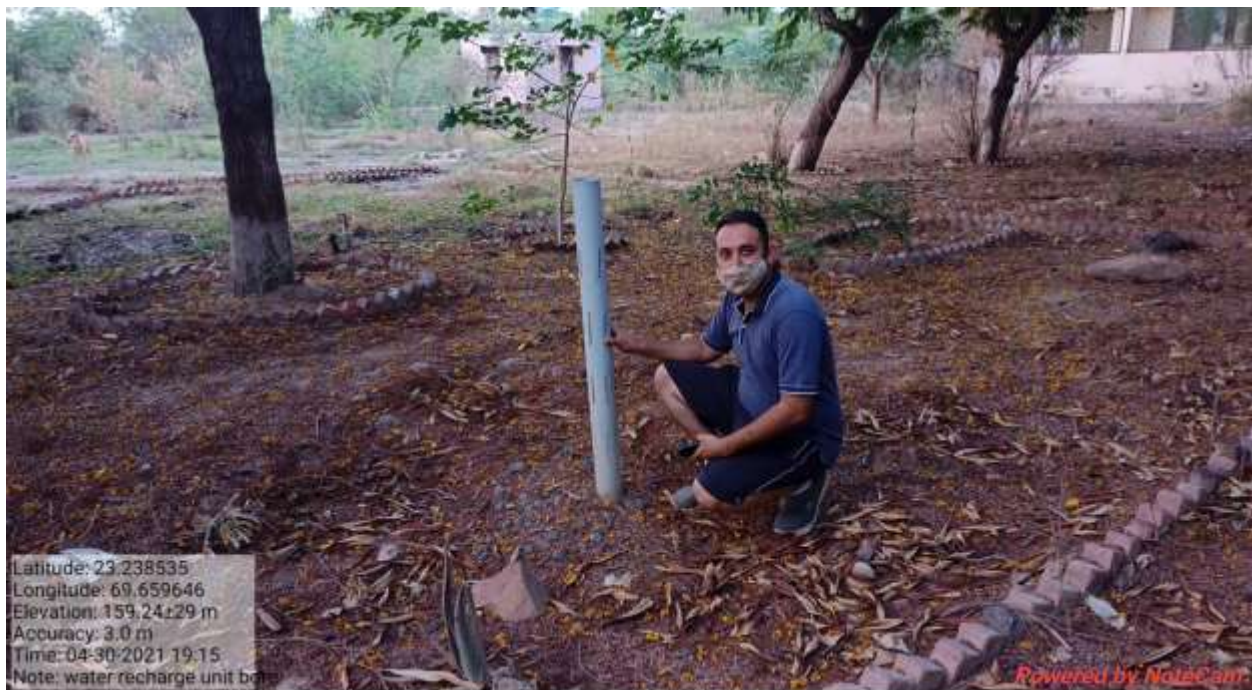
Water recharge

Green Square: Recharge pit and well,, Red circle: Recharge well, Blue square: Water harvesting bed
